ARCHAEOLOGY AND ARCHITECTURE IN THE IRON AGE HILLFORTS OF NORTHWEST PORTUGAL

ANT 679H
Anthropology Departmental Honors / Plan II Honors Program
The University of Texas at Austin

May 11th, 2017

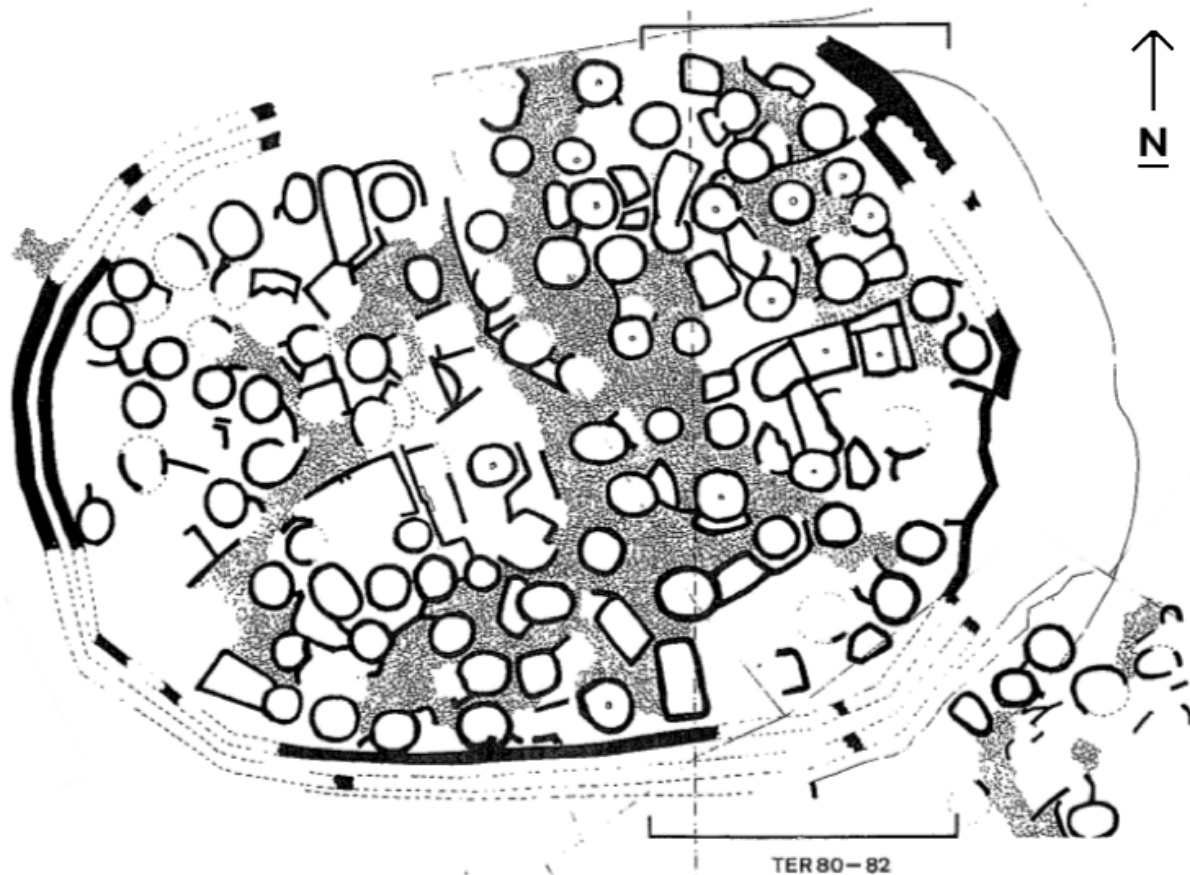
Figure 6: Rough plan-map of Terroso, made by Gonalo Cruz around 1907 (after Silva 1986).

There are significant discrepancies between the original map and more recent ones. For the most part, this can be attributed to the increased precision and detail of recent maps. However in certain cases, it seems that Cruz faithfully recorded something that simply disappeared in the following decades. For example, his map marks a central feature on the surface of structure T-23 (see Appendix 1 for clarification on the names of structures). This is now absent at the surface level, but central stones were found in the layers beneath. As will be discussed later, other structures exhibit successive central hearths, according to the excavators' interpretations (Gomes 2005:123).

Cruz's map is likely fairly reliable in recording the presence of whole structures or distinct central features, such as intentionally placed stones or hearths. But examination of current maps and existing structures indicates that the original map is clearly unreliable in terms of scale, orientation, and overall precision. It should only be referenced with extreme caution, and with full awareness of its inherent limitations.

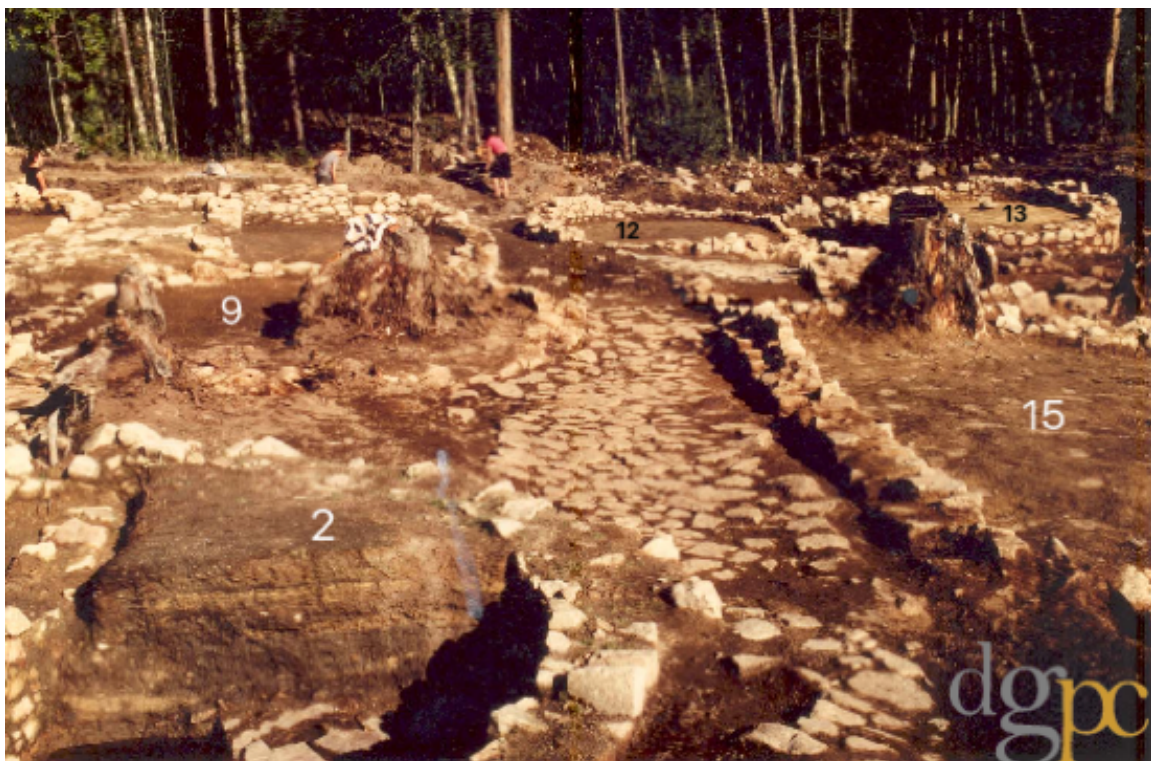
Figure 11: View looking east at one of Terroso's two 'major roads'
(photo: Direção-Geral do Património Cultural <http://arqueologia.patrimoniocultural.pt>).

organizing settlements around a *cardo* and *decumanus* (Figure 11). This observation is relevant, especially given the apparent chronology of the currently visible settlement plan. However, while organizing settlements around the intersection of major streets in rough correspondence with the cardinal directions is a Roman practice, it is not necessarily proof of a 'Romanized' settlement. An investigation of the road-building techniques employed in castros during various periods may allow for more meaningful conclusions on this matter. The presence of rectangular structures is interpreted as further evidence of Roman reorganization, which is a common view. The excavators observed differences in the general characterization of the evidence between Phase II and Phase III, namely in terms of construction techniques and encountered artifacts.

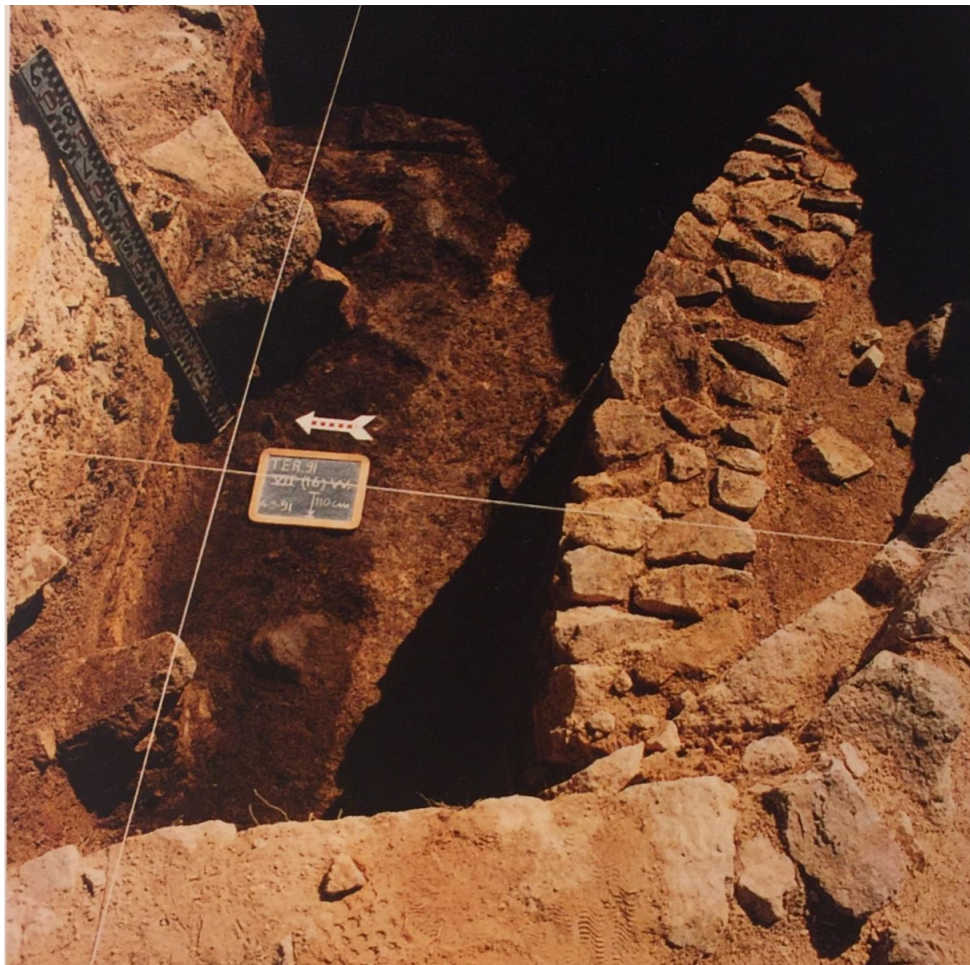
Figure 12: View of the interior of T-7 from above. The wall of T-7 frames the bottom of the picture. Part of an unidentified structure, buried beneath T-7, appears on the right (after Gomes 2005).

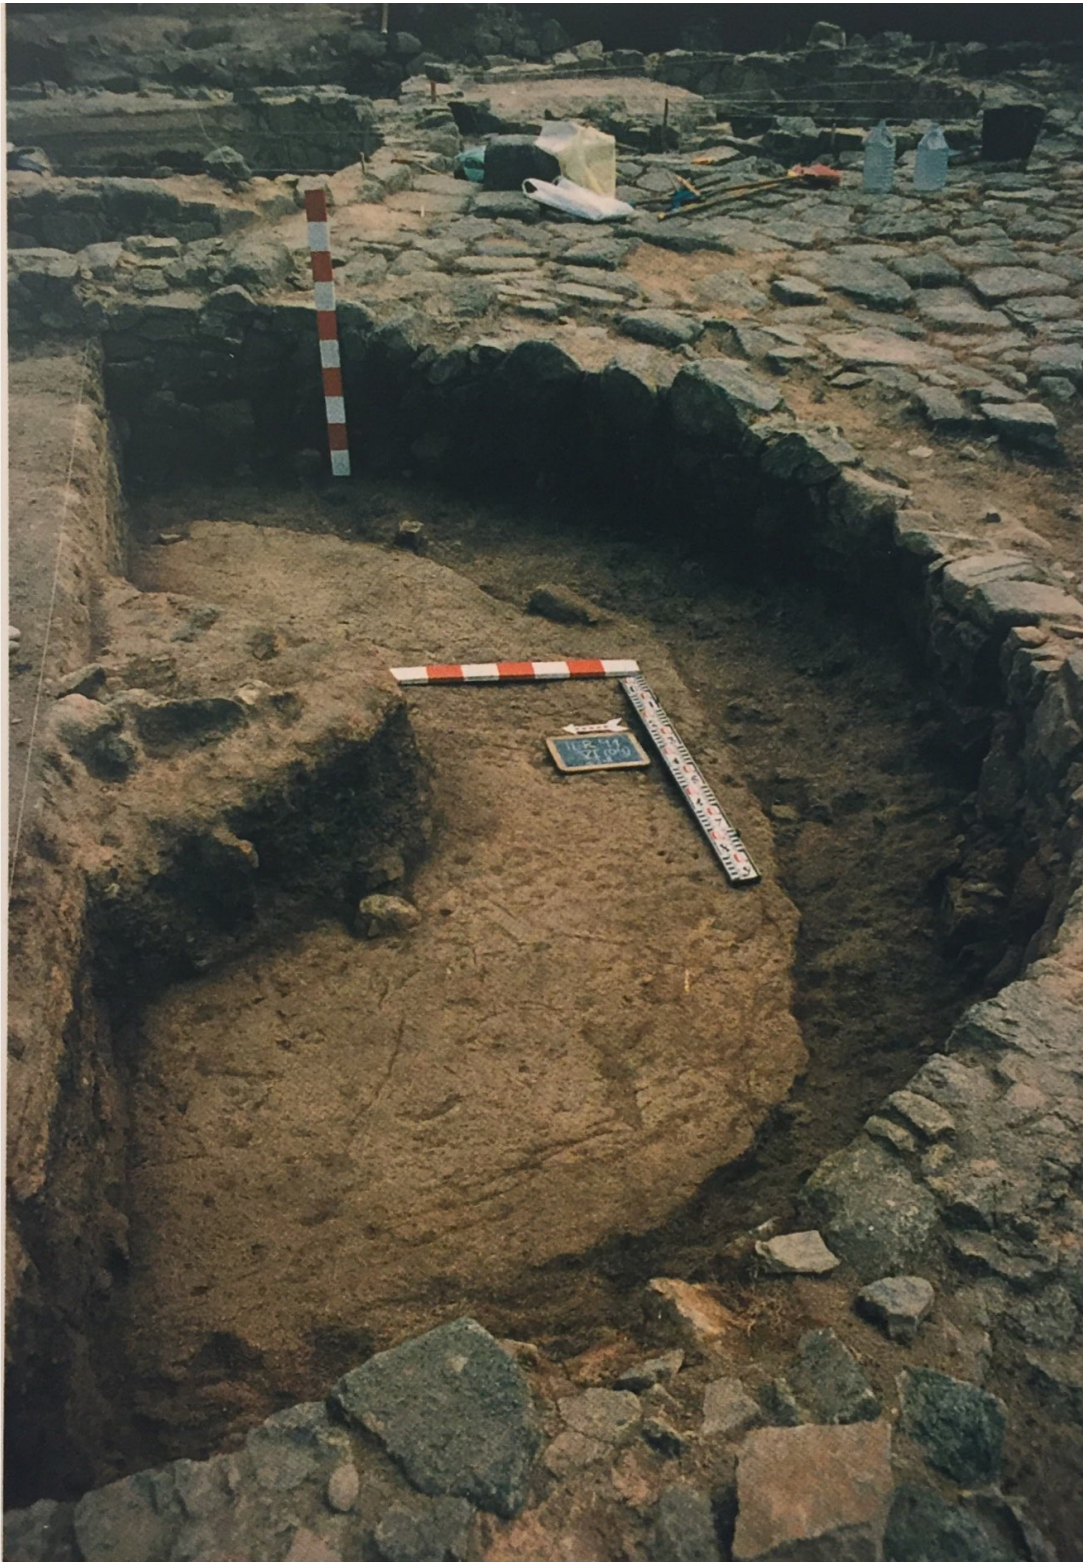
Figure 13: General view of T-6 (after Gomes 2005).

In T-6, which was constructed during Phase II, alterations did not take place despite the appearance of Phase III. It is unclear how this relates to the supposed destruction that took place across the site. The stratigraphy of this structure is characterized by a small number of layers, with very few artifacts encountered. The floors are very well made, but they are not as thick in the upper layers as those of nearby structures. Successive hearths were placed at the center of the structure, apparently being continually replaced as new floors were laid. Along the whole internal perimeter of T-6, the floor abruptly ceases to exist about 40 cm from the wall. Gomes (2005:123) provides a satisfactory explanation, speculating that the gap may have accommodated a bench made of perishable materials ([Figure 13](#)).

T-6 seems fairly unique, at least compared to the other buildings encountered at Terroso. This is based on the scarcity of artifacts and stratigraphic levels despite the longevity of the structure, the apparent presence of a wooden bench around the internal perimeter, and the peculiar description of its floors. On the stones of the external face of T-6's walls, at the level of the pavement, a thick coating of plaster was encountered (Gomes 2005:123). Its composition is unknown, since laboratory analysis was still underway at the time of Gomes' publication. He suggests that it was made of *saibro*, among other unknown components.

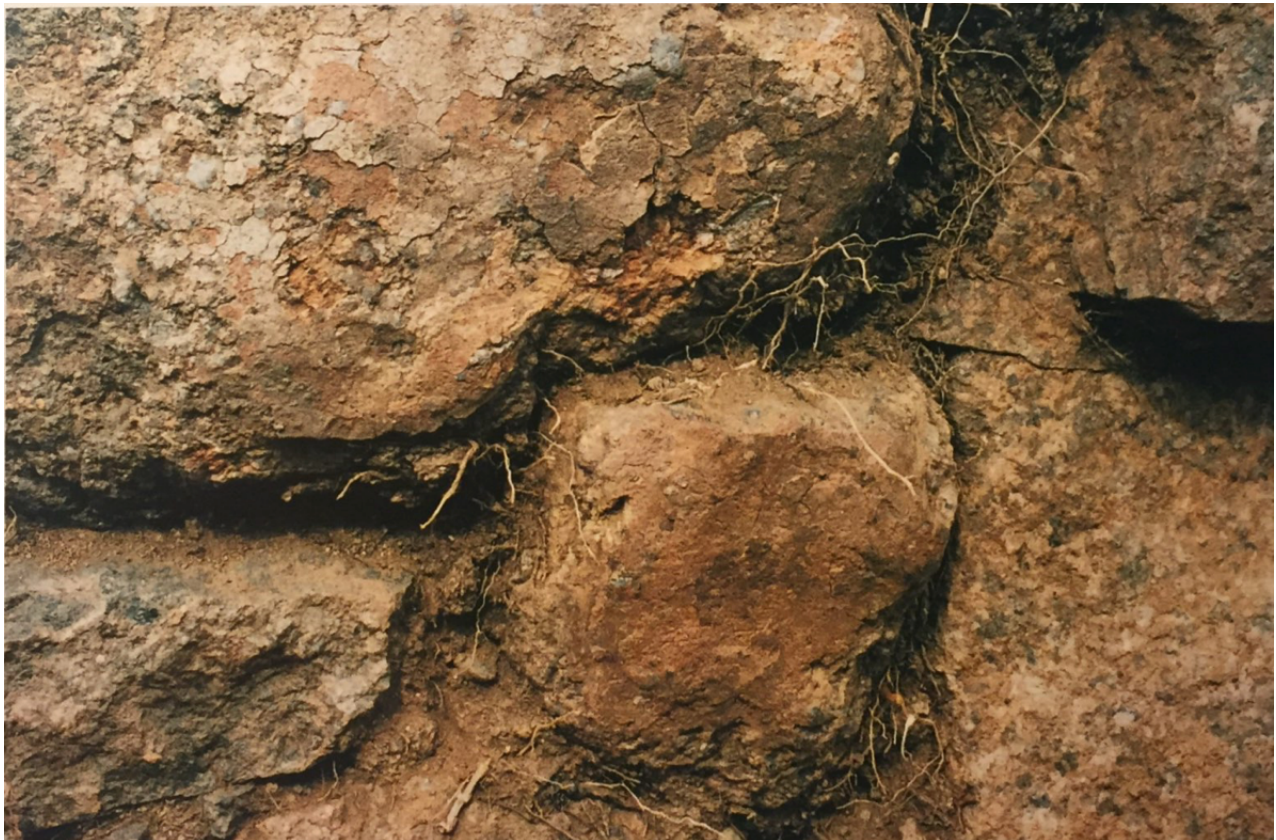
Figure 14: Detail of colored plaster on the internal wall of an unidentified structure (after Gomes 2005).

Gomes (2005:123) states that a thin layer of plaster, pink or reddish in color, was encountered on the stones of the internal faces of multiple other Phase III constructions. This leads him to conclude that, at least during Phase III, the internal and/or external walls of certain structures at Terroso may have been fully or partially coated with a colorfully painted plaster (Figure 14).

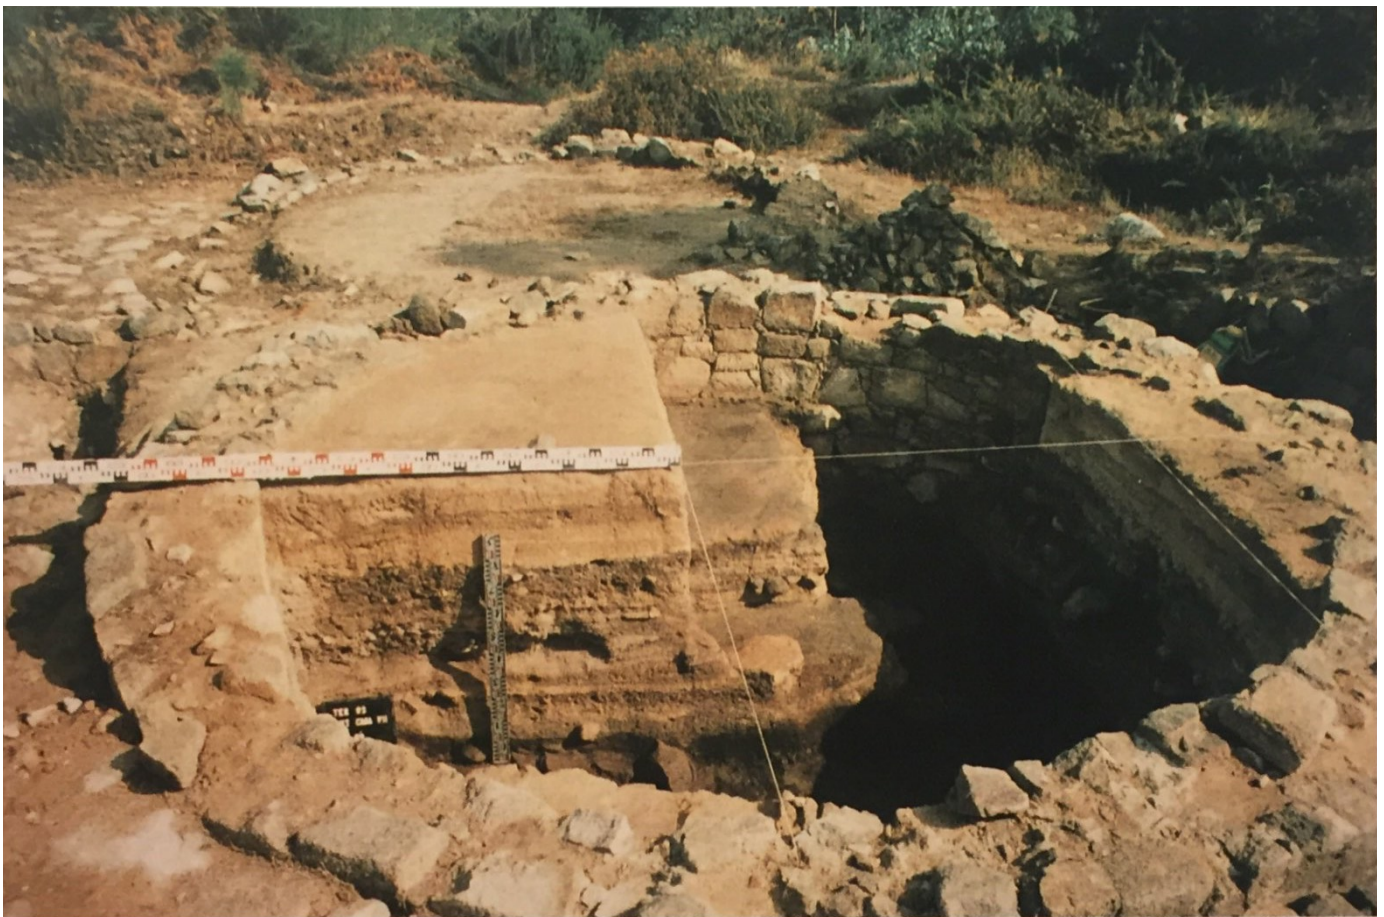
Figure 16: General view of T-7 (after Gomes 2005).

Several photographs are available for T-7 (see Figures 15 and 16), in addition to a profile-map (Figure 9) and an exhaustive description of its stratigraphy. Levels 16-13 vary in composition, with no artifacts other than the Final Bronze Age ceramics found in level 16. Gomes (2005:117) also notes successive thin floors in the “deepest levels.”

positioning of the “hearth” is less problematic, because Gomes (2005:117) identifies level 6 as the first level of occupation of T-7. This places the construction of T-7 in Phase III. In level 5, the first wheel-made ceramics are encountered, which substantiates this chronology. Part of a circular structure, possibly dating to Phase II, was encountered beneath T-7 in its interior (see Figure 12). Gomes does not provide the stratigraphic level at which this older structure was encountered.

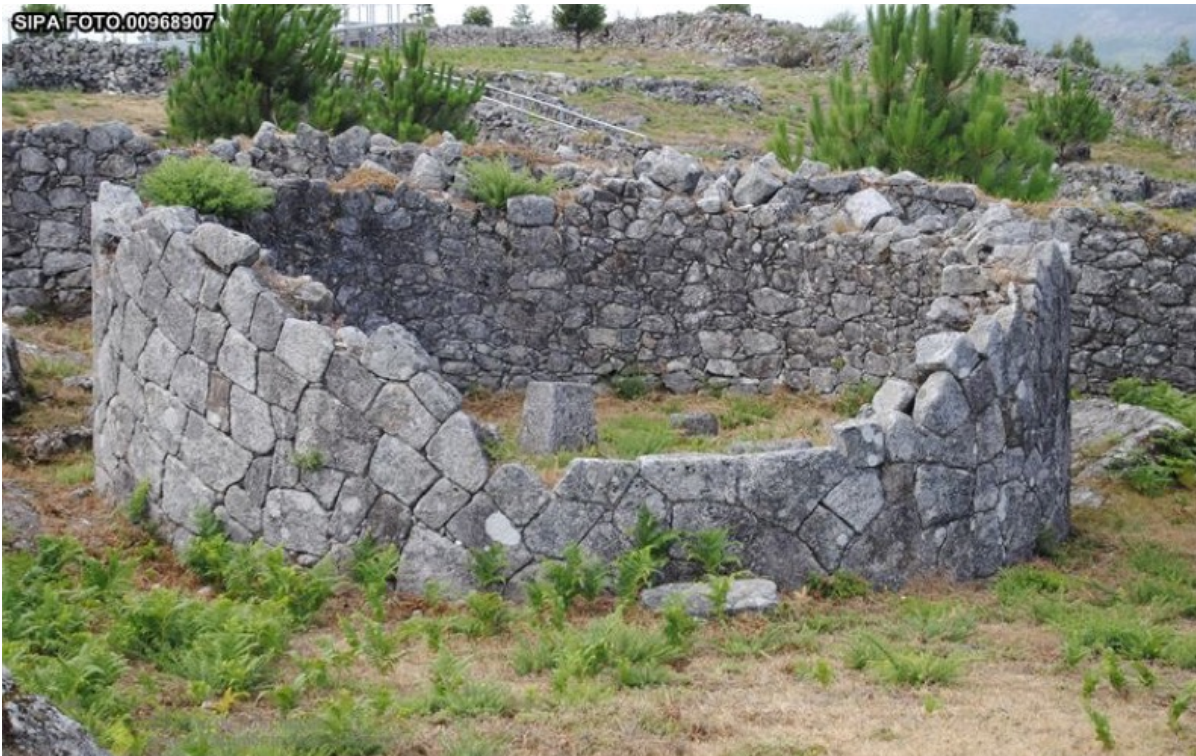
Figure 20: View of Lz-8. Note the elevated doorsill, the central stone, and the helicoidal pattern on its external face (both photos: Direção-Geral do Património Cultural <http://www.monumentos.pt/>).

Some of these delimiting walls, as well as many of the structures, exhibit a helicoidal pattern in the laying of their stones. The term 'helicoidal,' which normally refers to spirals, has a very specific and fairly unintuitive meaning in the context of castro archaeology. It basically refers to the laying of stones in oblique courses, but the aesthetic effect created by this technique is far more difficult to describe than it is to visually recognize (see Figures 20 and 21). In every instance of the helicoidal pattern, there is an extreme level of precision in the working and positioning of the stones. The result is a very flat surface created by an almost seamless interlocking of well-shaped granite stone. The technique creates a rather intriguing visual effect, perhaps due to the somewhat unpredictable directionality of the stone courses. Based on photographs, it seems that helicoidal patterns are only used on the external faces of structures, while their internal faces employ smaller, more irregular stones. The delimiting wall that encloses nucleus X reflects this practice as well, with only its external face exhibiting the helicoidal pattern (Figure 22). Other delimiting walls could have been constructed with a helicoidal pattern on both faces, but currently available photographs provide no further insight on the matter.

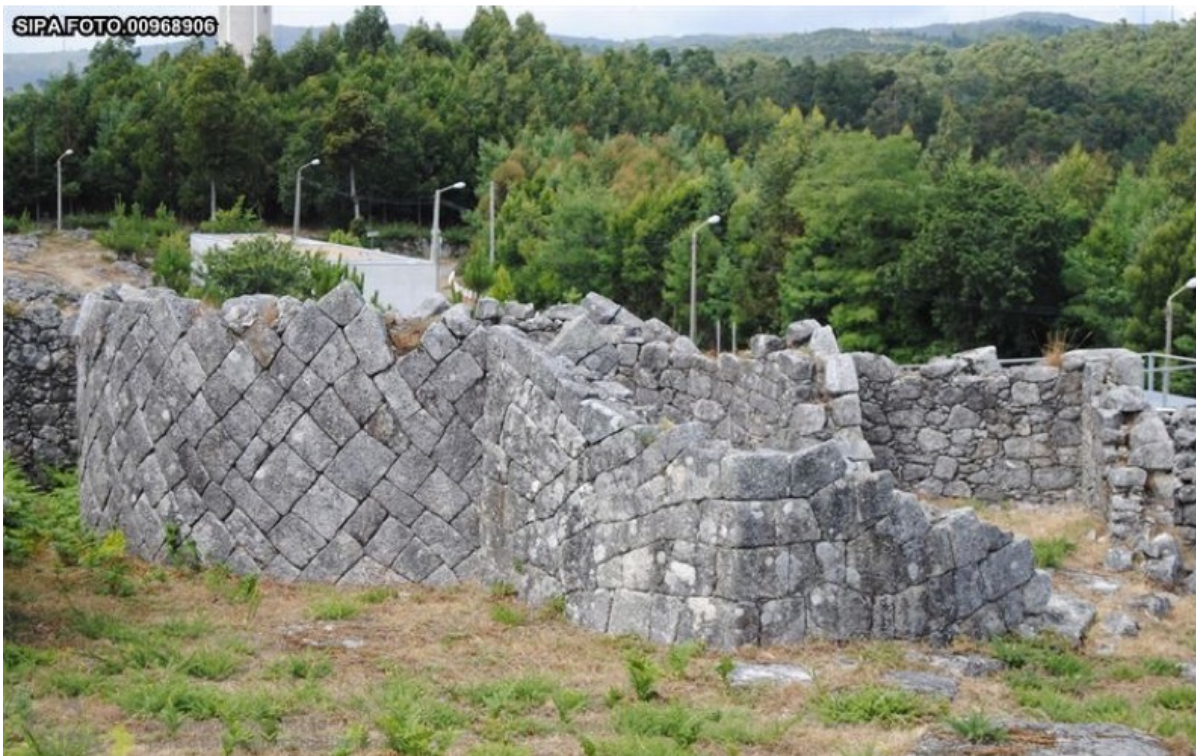
Figure 21: View of Lz-9. Note the helicoidal pattern and the vestibule. In the background of both photos, note the unimpressive internal face of the delimiting wall that surrounds nucleus X.

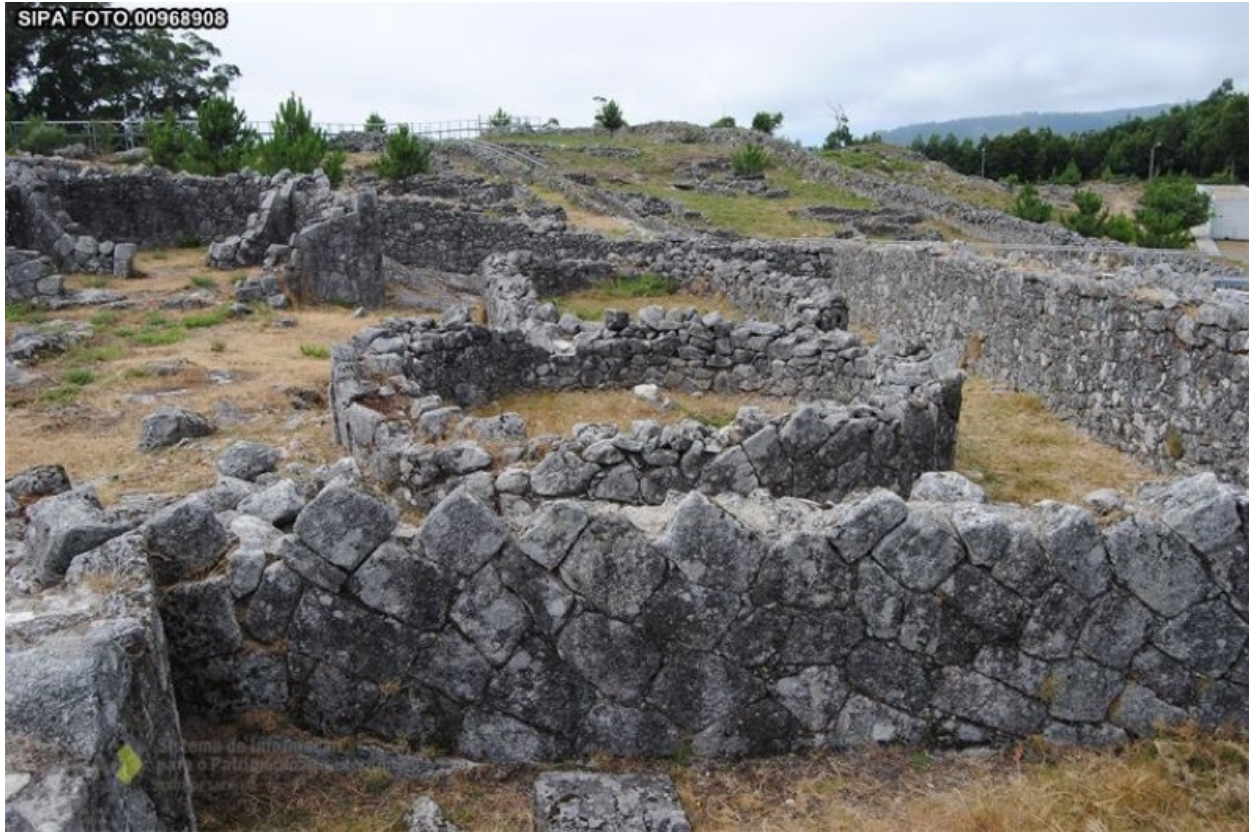
Figure 22: View of the delimiting wall that surrounds nucleus X, showing its helicoidal external face. In the background (top left), another view of Lz-9 (photo: see Figure 20).

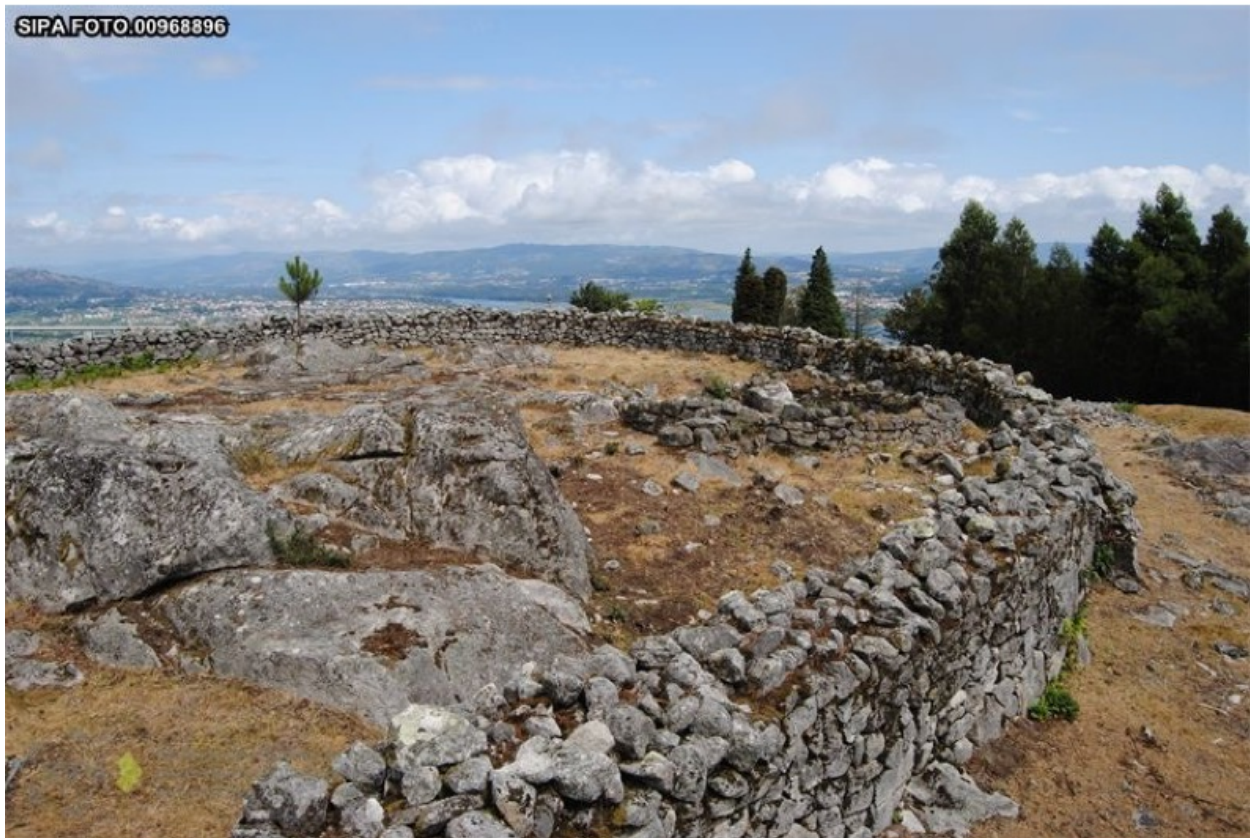
Figure 30: Partial view of the grand enclosure (photo: see Figure 20).

Directly inside the enclosure, about 0.9 m from the entrance, are the remains of *duas pequenas paredes talhadas na própria rocha* — “two small walls carved in the rock itself” (Oliveira and Viana 1954:45). The meaning of this is not entirely clear, but presumably the “small walls” were carved from the natural granite outcrops rather than being constructed with stones. The authors speculate that these “small walls” may have formed an “obligatory passage” from the entrance to the interior of the enclosure (Figure 29: A). Large granite outcrops dominate the surface of the grand enclosure (Oliveira and Viana 1954:46; Figure 30).

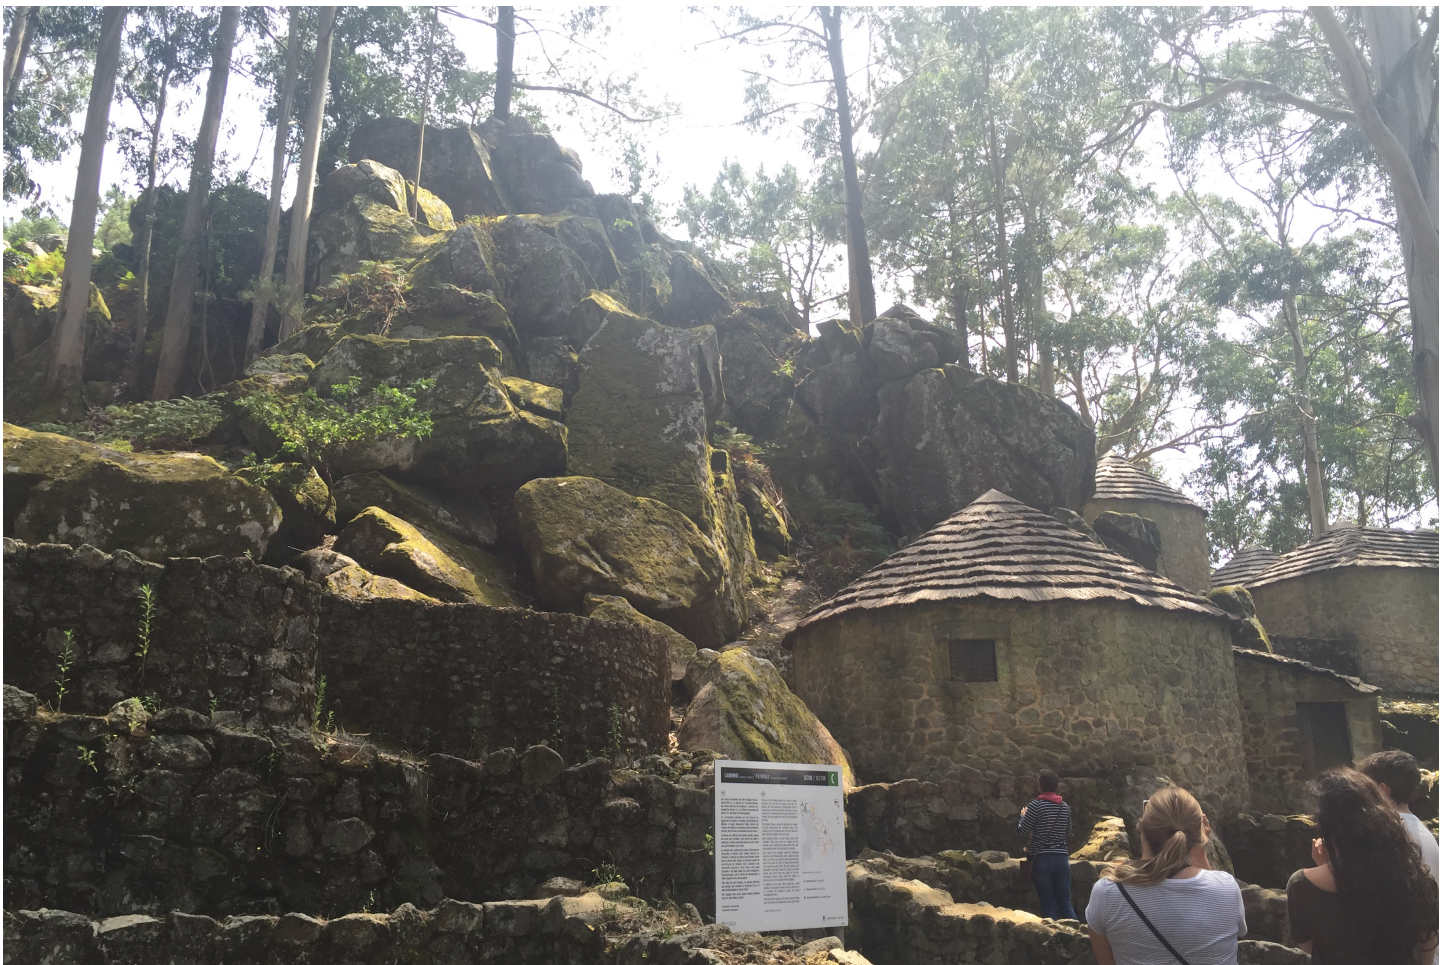
Figure 34: Partial view of sector C, taken from the road (in front of the entrance to C-2), facing southwest. Note a section of the “crown” looming above. The nearest reconstructed building is C-9, with a small portion of the reconstructed C-8 visible behind it. Farther in the background, a glimpse of the reconstructed CV-3 and CV-1 (photo by author).

The Castro de São Lourenço occupies a prominent monte in the county of Esposende, in the district of Braga. Its peak reaches an elevation of 200 m, with *uma coroa formada por uma imponente massa granítica* — “a crown formed by an impressive granite mass” (Almeida 2006:72; [Figure 34](#)). The monte is very steep on all sides, with a general prevalence of large granite outcrops. Flat surfaces are a rarity, and there is no ‘central platform’ of which to speak ([Figure 35](#)).

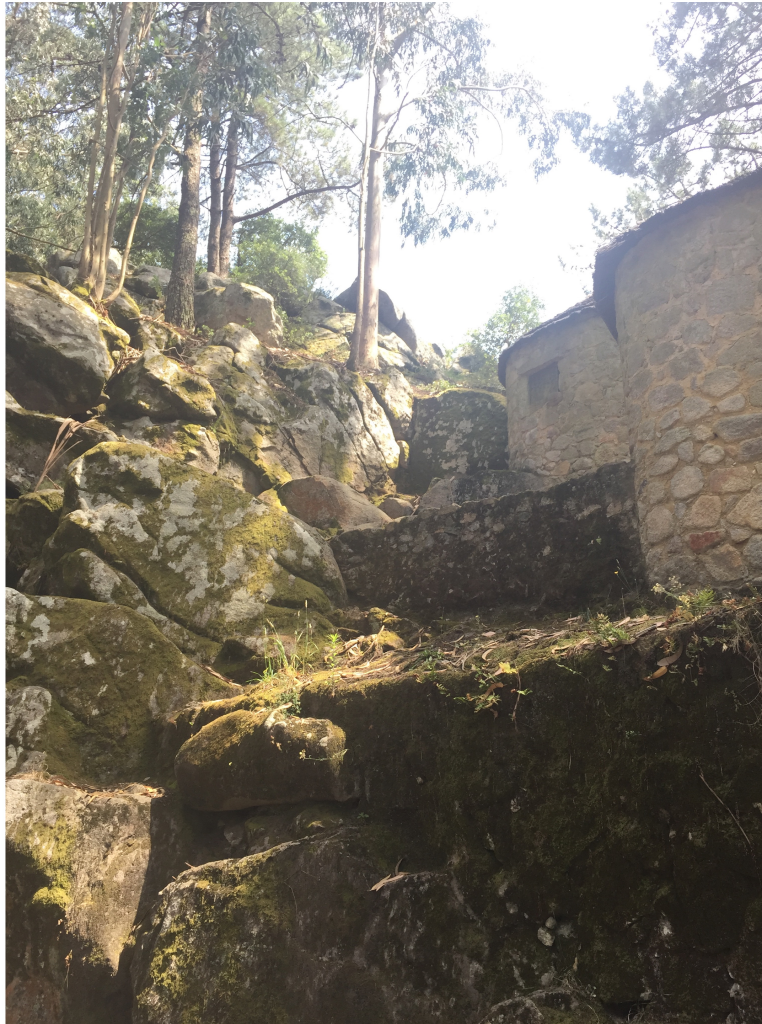
Figure 35: Partial view of CV-3 and CV-1 from the edge of sector C (in the general vicinity of C-5 and C-6), facing southeast. Note the steep incline and the clear 'terracing' (photo by author).

In addition to these common trends, there are a number of peculiarities, again pertaining to Phase III. At São Lourenço, even the larger construction stones are bound together with copious amounts of clay, rather than merely being stacked. This may reflect a greater need for structural stability (compare Figure 35 with Figure 22). Central hearths are present in multiple structures at Terroso and São Lourenço. Outdoor hearths are attested at all three sites. Ovens are recorded at Santa Luzia, appearing in a variety of locations. The exact criteria behind the attribution of the terms ‘hearth’ and ‘oven’ to archaeological features are mostly unknown, and likely somewhat arbitrary. Further research on this topic is necessary, and a more standardized set of terms with explicit criteria will be essential. Vestiges of drainage channels are tentatively identified

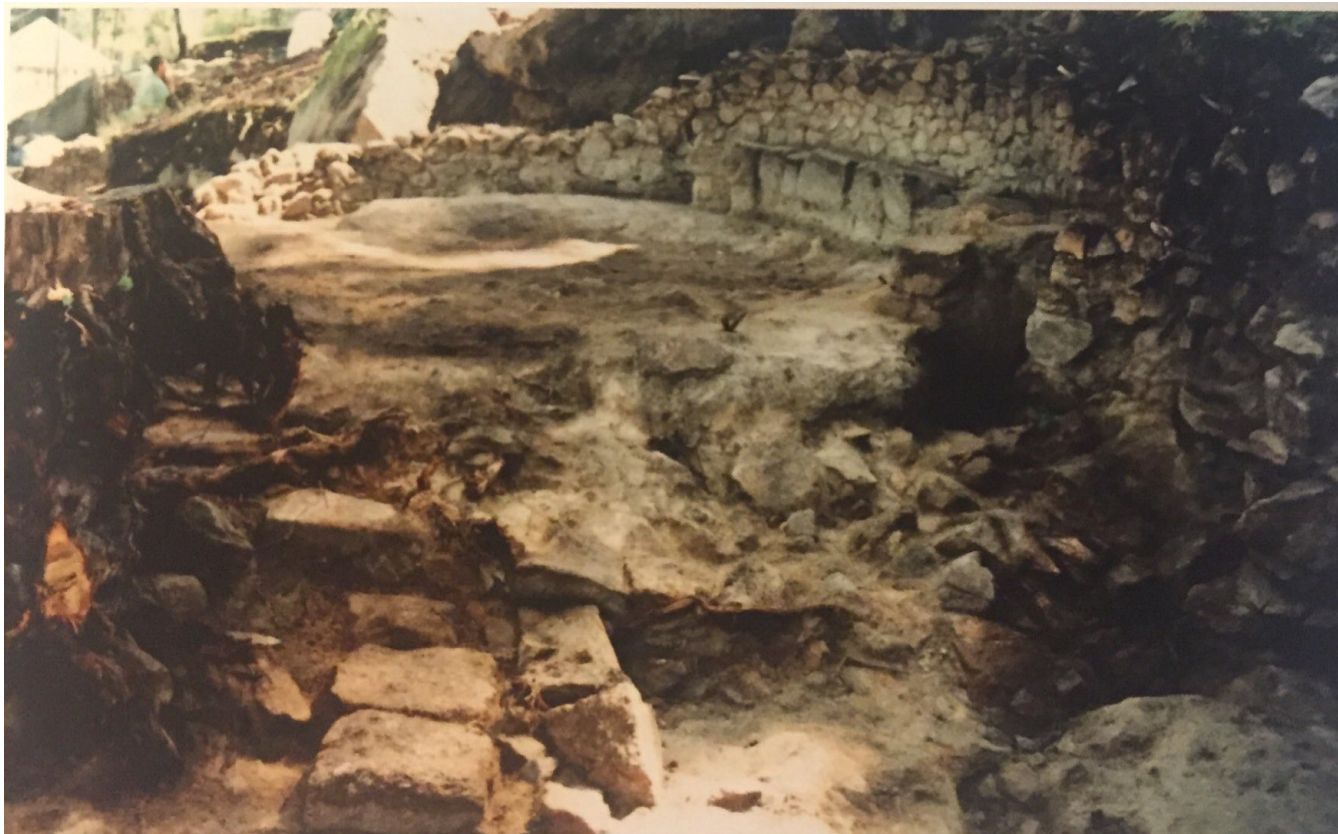
Figure 40: General view of C-9, showing its internal stone bench. Note the heavily damaged state of the remains (after Almeida and Almeida 2015).

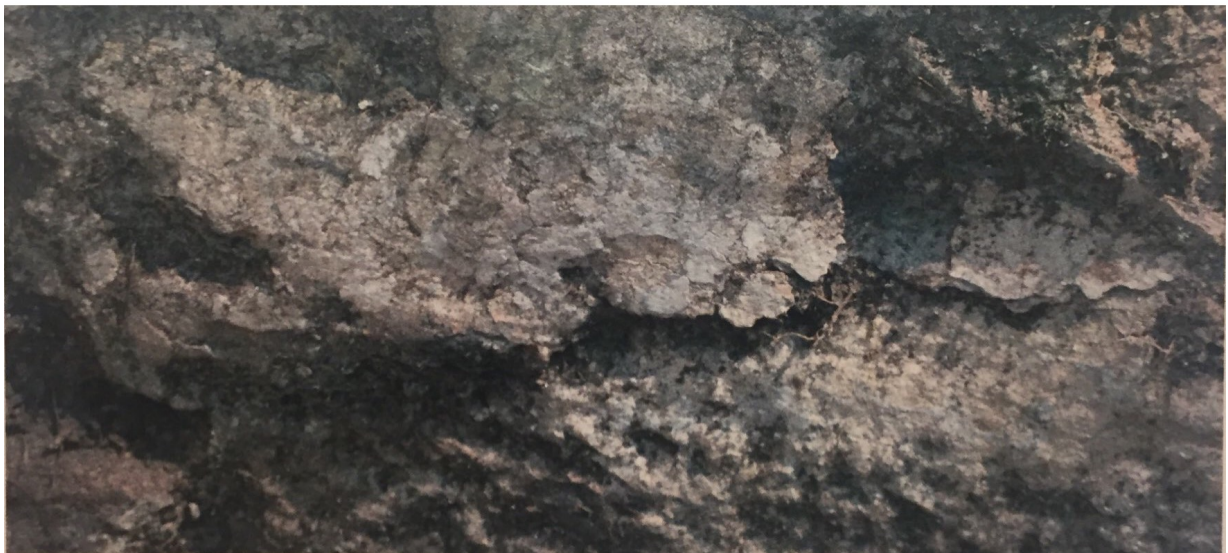
Figure 44: Detail of plaster on the internal wall of CV-5 (after Almeida and Almeida 2015).

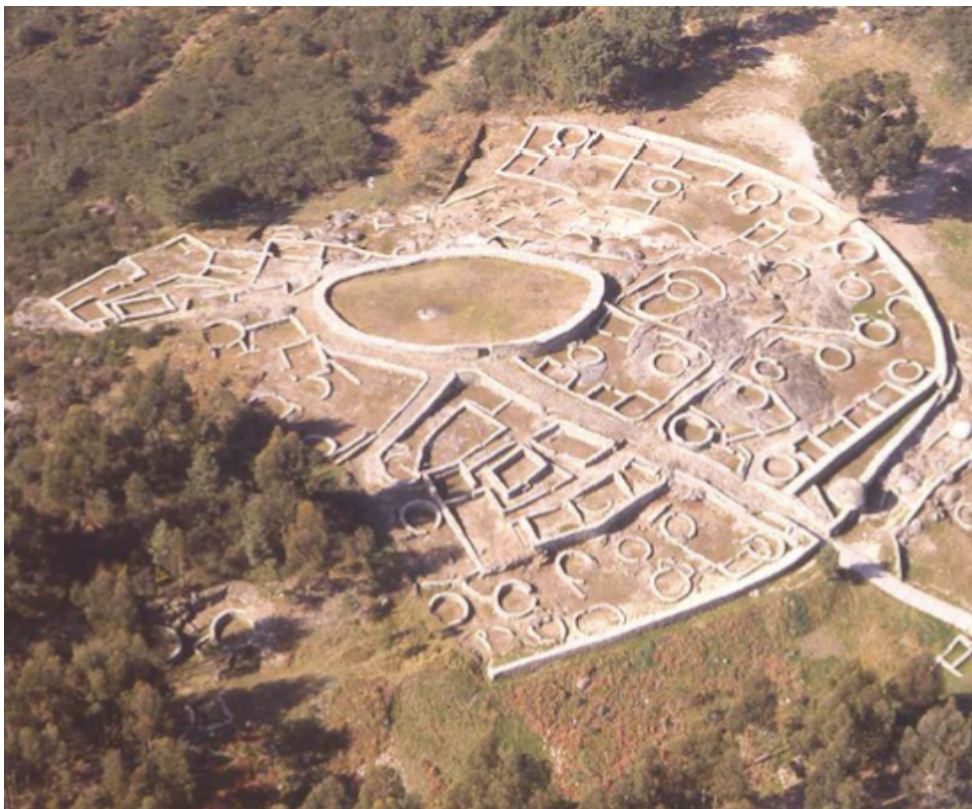
Figure 46: General view of Monte Mozinho. Note the 'grand enclosure' in the center (photo: Câmara Municipal de Penafiel <http://www.cm-penafiel.pt/>).

The Castro de Monte Mozinho is a well-known site in the county of Penafiel, in the district of Porto (Almeida 1980; Soeiro 2000-2001). It warrants mention in this thesis because it contains what can only be described as a 'grand enclosure' similar to the one seen at Santa Luzia ([Figure 46](#)). The settlement plan visible at this site pertains almost certainly to the Roman Period, and its spatial organization seems very distinct.

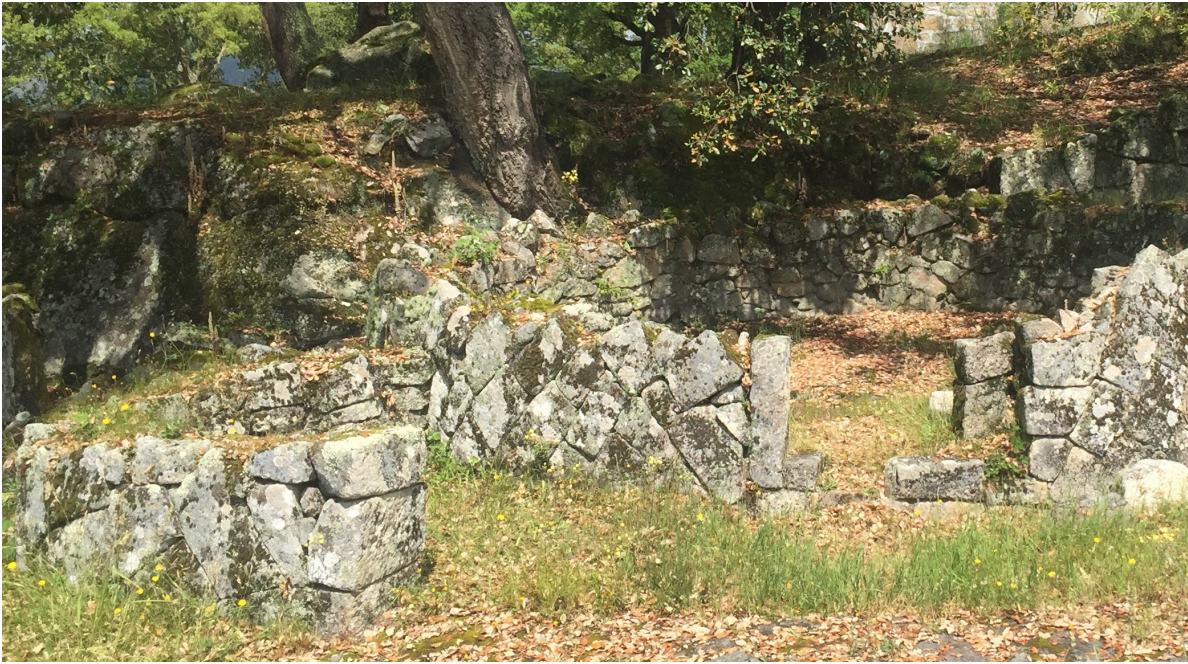
Figure 47: Helicoidal pattern on a structure at Briteiros (photo by author).

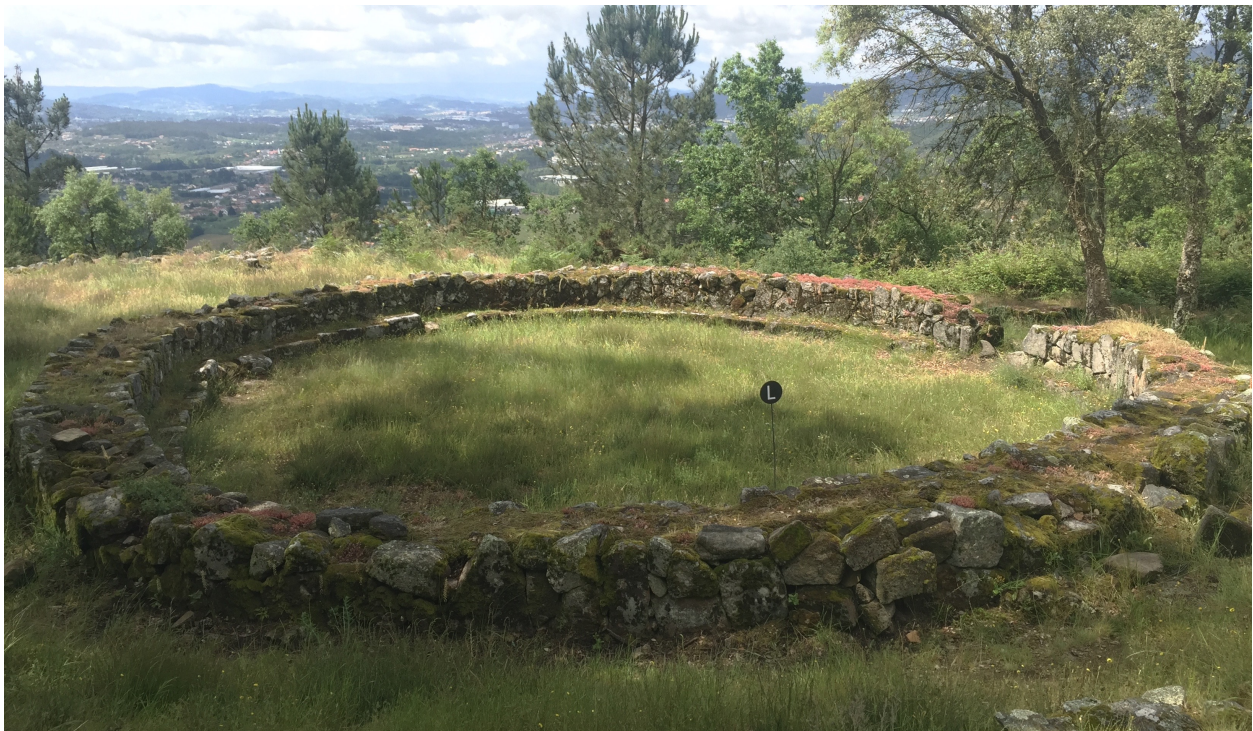
Figure 48: The very large circular structure at Briteiros (photo by author).

The Citânia de Briteiros in the county of Guimarães, in the district of Braga, is perhaps the best known of all the castros in Northwest Portugal. This site offers an informative collection of Phase III architecture, including some examples of the helicoidal pattern ([Figure 47](#)). It also exhibits an intriguing and entirely unparalleled construction: a very large, almost perfectly circular structure with a stone bench lining its entire internal perimeter ([Figure 48](#)). According to my own measurements, this structure has an approximate diameter of 12 m, with a thick double-wall. It occupies a fairly isolated platform near the edge of the monte, separated from most other visible structures. These characteristics clearly differentiate this structure from the ‘grand enclosures’ seen at Santa Luzia or Monte Mozinho. Other sites that warrant further study include Citânia de Sanfins in the district of Porto, owing to its size and abundant architecture, and Cividade de Bagunte in the county and Municipality of Vila do Conde, district of Porto, owing to the fact that I am involved in annual excavations at this site. This is only a preliminary and abridged list of a few major sites, but it serves to provide an impression of what lies ahead ([Figure 3](#)).
